Thornton Creek Water Quality Channel

FINAL REPORT

October 28, 2009

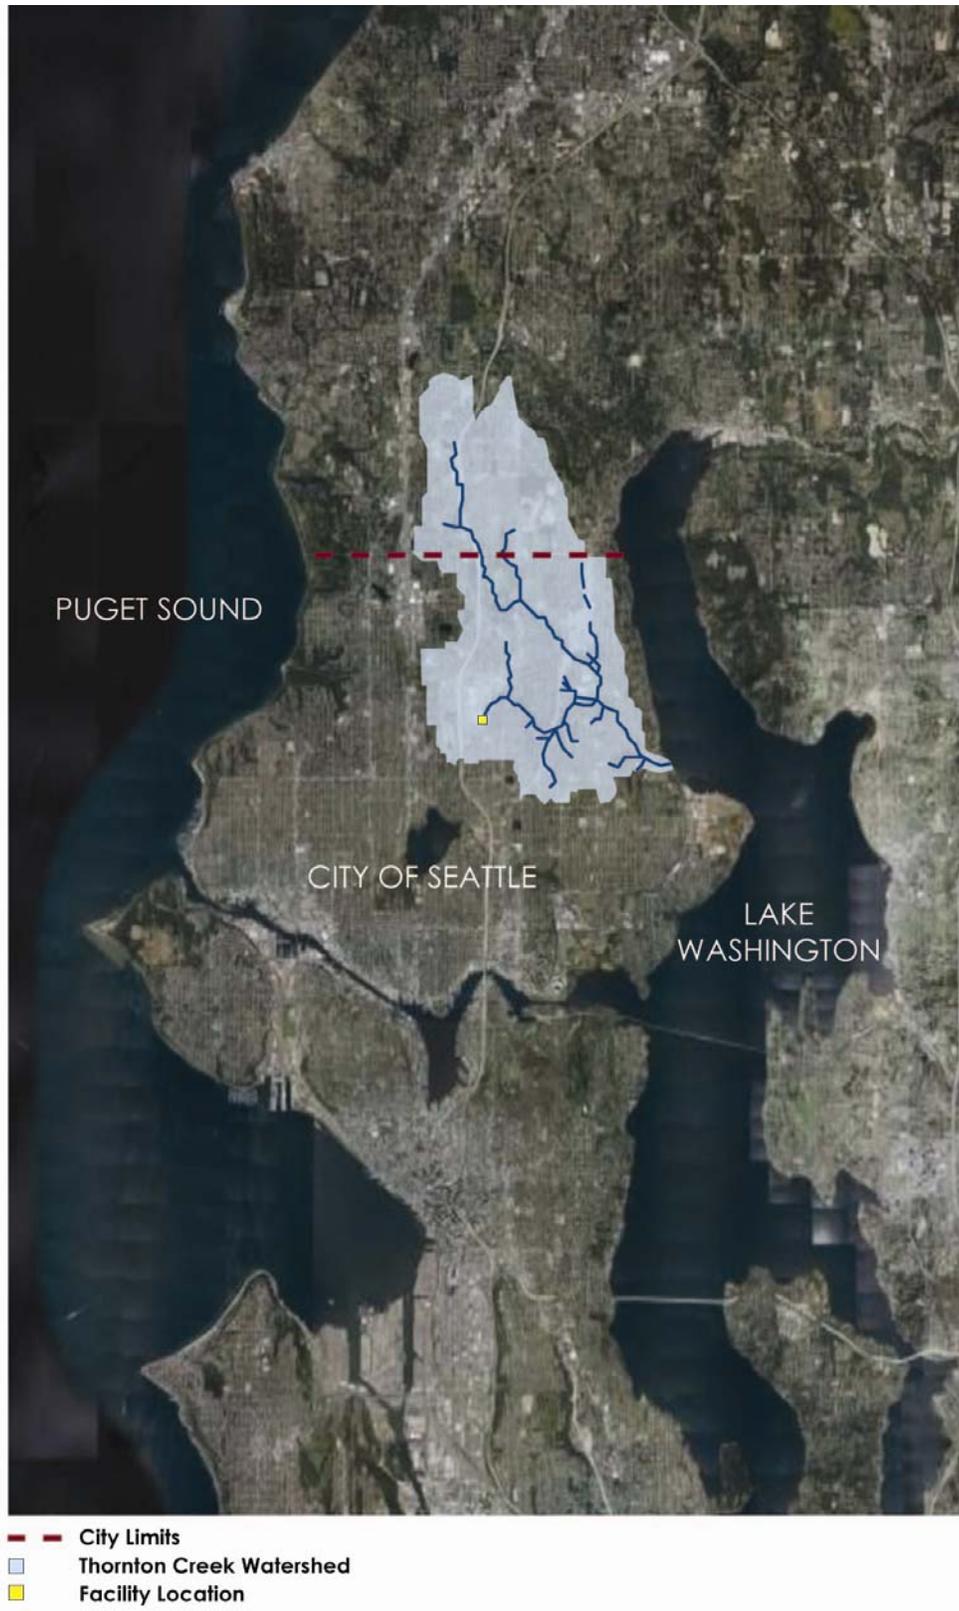
Figure 1 - Thornton Creek Watershed

The Thornton Creek Watershed is a highly developed watershed located in northeast Seattle that drains to Lake Washington (See Figure 1 – Thornton Creek Watershed). At 11.6 square miles, it is Seattle's largest watershed. The highly urban nature of this watershed has created water quality and flow control problems in Thornton Creek which has degraded the creek's function as aquatic habitat.

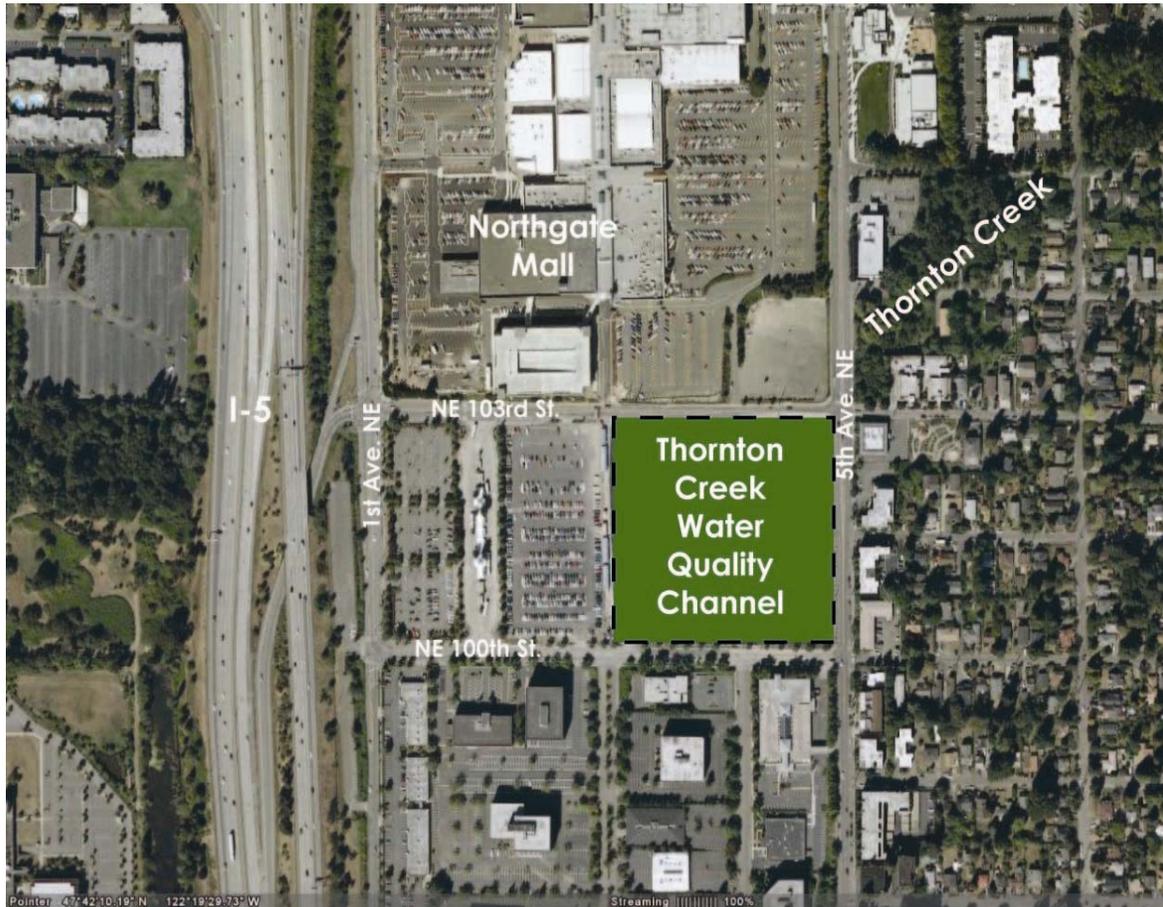
Figure 2 - Facility Location

The Facility is located in the Northgate neighborhood between NE 103rd Street and NE 105th Street and 3rd Avenue NE and 5th Avenue NE, near the headwaters of Thornton Creek's South Fork (See Figure 2 – Facility Location).

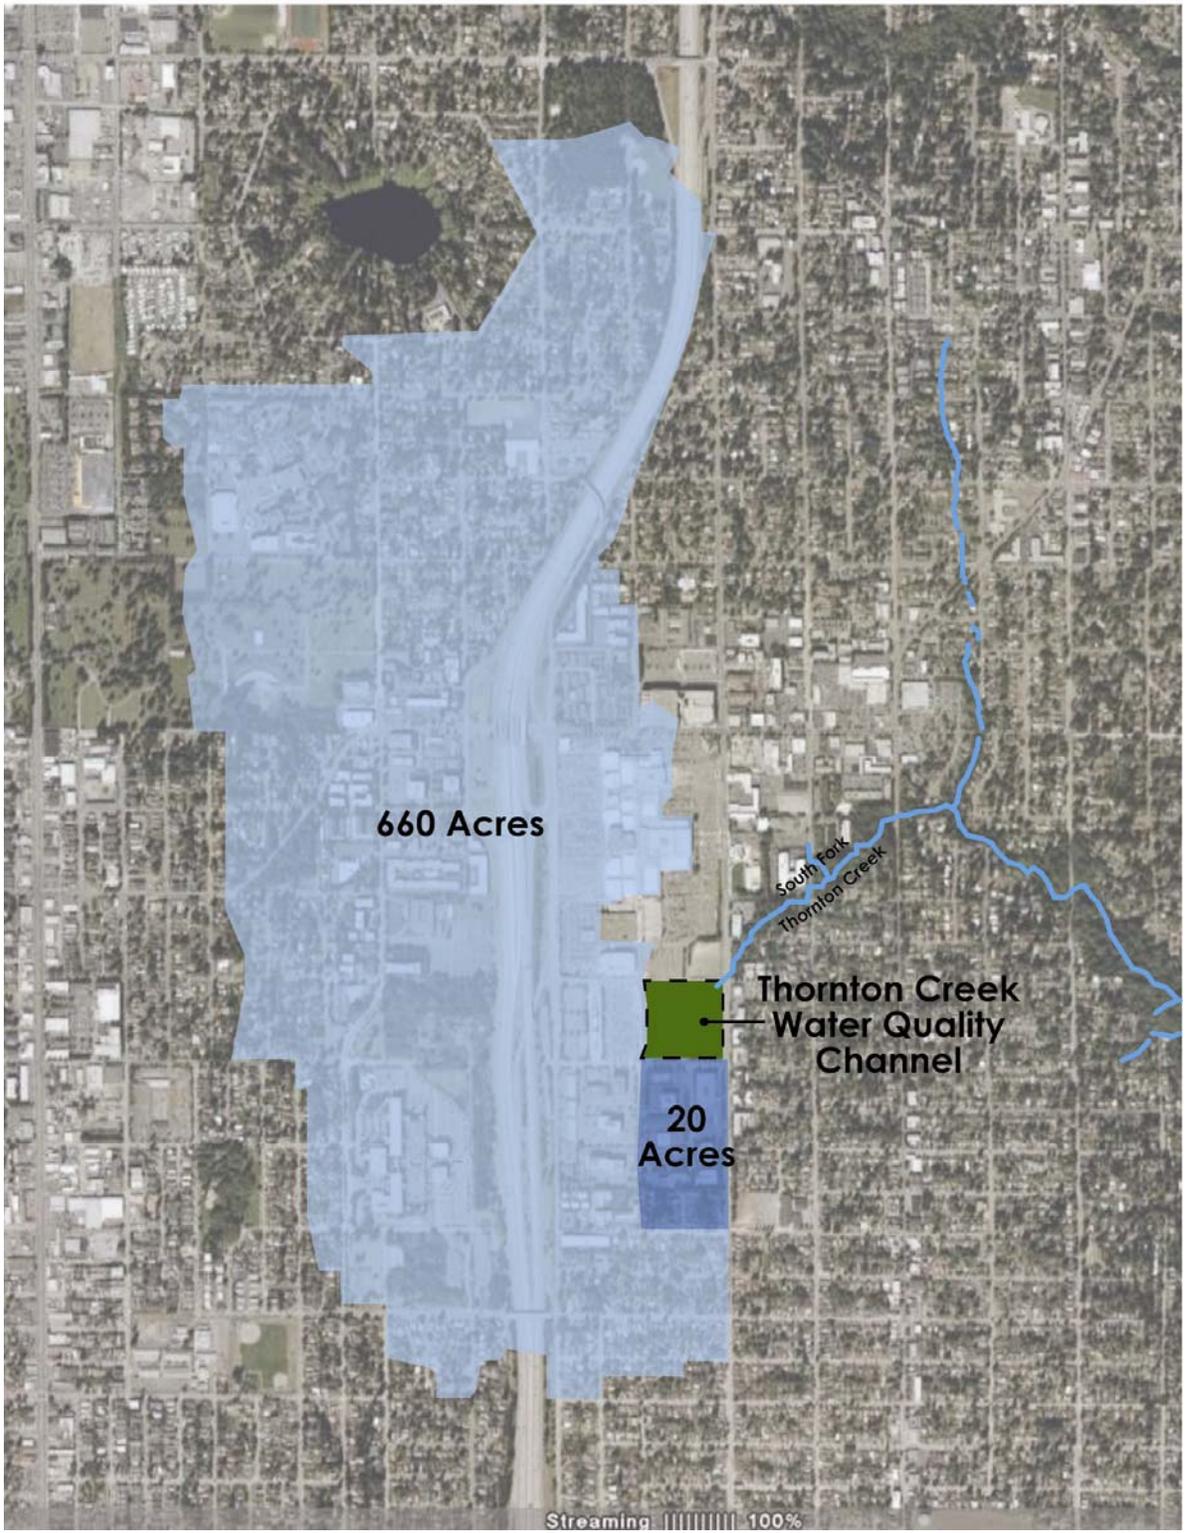
Figure 3 - Subbasins Draining into the Facility

Stormwater runoff and seasonal base flows from approximately 680 acres drain to the Facility and eventually enter Thornton Creek's South Fork. Flows drain to the Facility from two subbasins: a 660 acre subbasin that stretches west and north of the Facility and a 20 acre subbasin south of the Facility (See Figure 3 – Subbasins Draining into the Facility). Flows from the 660 acre subbasin begin west of I-5, around North Seattle Community College and the Seattle North Precinct Police Station. After passing through a storm surge pond at the college, flows cross under I-5, and merge with a small tributary and stormwater runoff coming from Northgate Mall, I-5 and the surrounding roadways. The second 20 acre subbasin includes 3rd Avenue NE and an office park south of this street. The majority of flows from these two subbasins pass through the Facility, reenter the piped drainage system at the Facility's outlet, and discharge to Thornton Creek's South Fork on the other side of the roadway, near the corner of 5th Avenue NE and NE 103rd Street. Prior to the Facility's construction, flows from both basins discharged to Thornton Creek's South Fork from the piped drainage system at the same location, near the corner of 5th Avenue NE and NE 103rd Street.

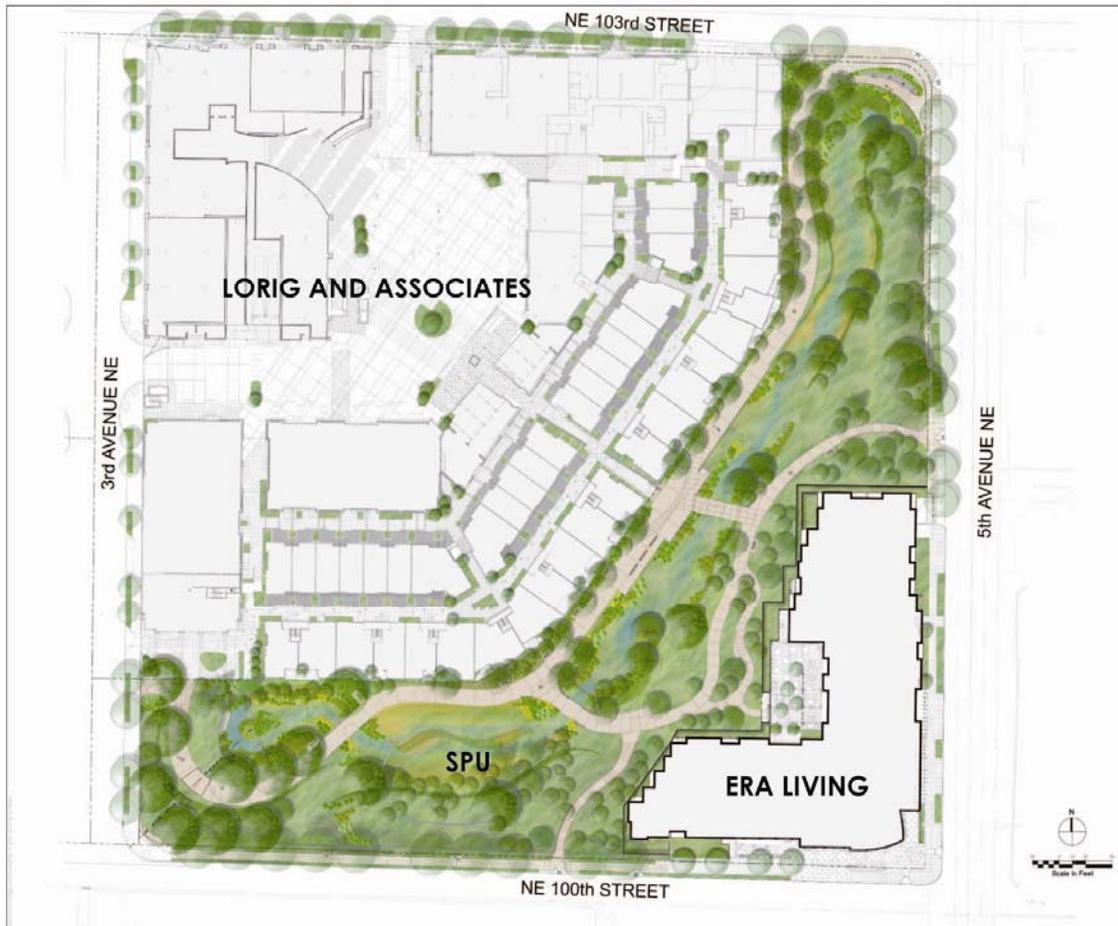
Figure 4 - Parcel Ownership

In June 2004, the Stakeholder Group supported the hybrid option. SPU acquired the Facility's 2.7 acre site in coordination with adjacent property owners via a joint venture agreement. A plat adjustment created three separate parcels, with the Facility's parcel located in the center to optimize both stormwater treatment and private development opportunities. The private parcel to the northwest provides multi-family housing and commercial space, while the private parcel to the southeast provides retirement community housing (See Figure 4 – Parcel Ownership).

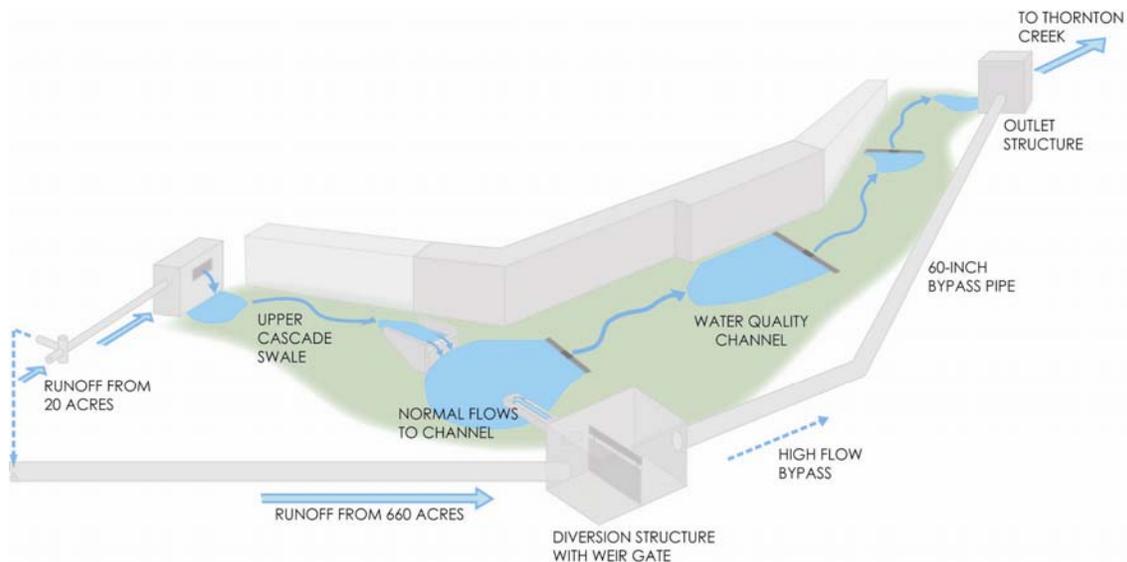
The majority of the stormwater treatment at the Facility occurs within the Water Quality Channel, although some treatment may occur within the Upper Cascade Swale (See Figure 5 - Schematic of Stormwater Treatment Facility Function and Figure 6 – Water Quality Treatment and Flow Control Elements). The Water Quality Channel is a modified biofiltration swale. Water quality treatment occurs when stormwater flows through the Wet Bioswale Terraces, slowing the water down and allowing sediments and associated pollutants to settle out. The Water Quality Channel receives year round base flow and the majority of storm flows from the two upstream basins (680 acres total). Higher flows bypass the Facility and continue through the existing 60-inch diameter storm pipe.

The Facility's water course is created by two diversions (See Figure 5 - Schematic of Stormwater Treatment Facility Function and Figure 7 – Flow Diversions). One diversion directs stormwater and base flows from the 20 acre subbasin into the Upper Cascade Swale located at the site's southwest corner. The Upper Cascade Swale flows into the Water Quality Channel. The second diversion, located in the center of the site, directs the majority of the 660 acre subbasin's flows from the existing 60-inch storm pipe into the Water Quality Channel. A weir gate within this diversion structure creates a backwater condition that directs all base flows and the majority of storm flows into the Water Quality Channel. Flows from large storm events overtop the weir gate, bypassing the Water Quality Channel to remain in the 60-inch storm pipe. The weir gate level can be manually adjusted. Hydraulic modeling of the Facility indicates that there will be no significant changes to backwater or downstream flows from pre-Facility conditions (Herrera 2007).

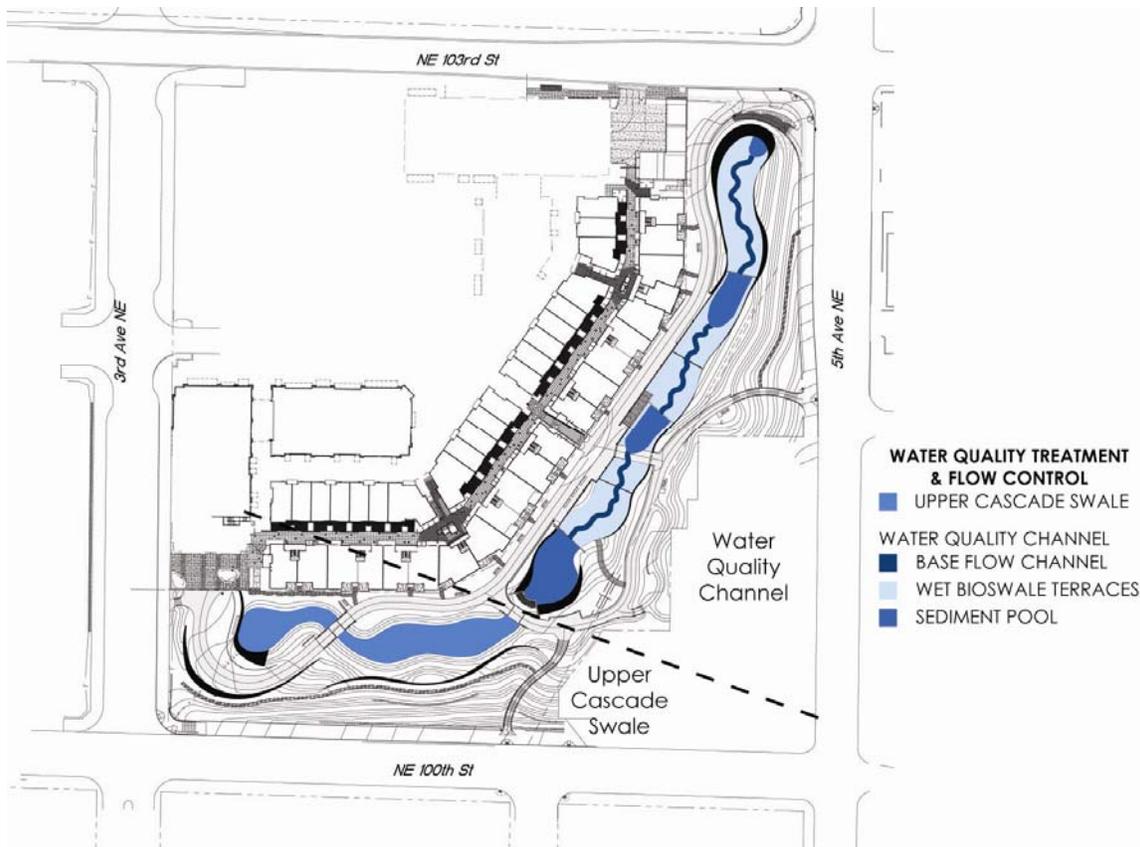
Figure 6 - Water Quality Treatment and Flow Control Elements

The Water Quality Channel consists of the Base Flow Channel, Wet Bioswale Terraces, and Sediment Pools (See Figure 6 – Water Quality Treatment and Flow Control Elements). The Base Flow Channel continuously directs water through the Water Quality Channel and back into the existing 60-inch storm pipe where it continues to Thornton Creek’s South Fork. Storm flows that crest the Base Flow Channel spread across the adjacent vegetated Wet Bioswale Terraces for treatment. In-channel flow spreaders help to spread the water evenly. The Sediment Pools provide areas for larger sediments and associated pollutants to settle out to facilitate maintenance. The Water Quality Channel’s design is intended to allow for natural channel dynamics. A low permeability zone approximately 15 feet wide within the center of the Water Quality Channel allows for the Base Flow Channel to reestablish itself after significant storm events.

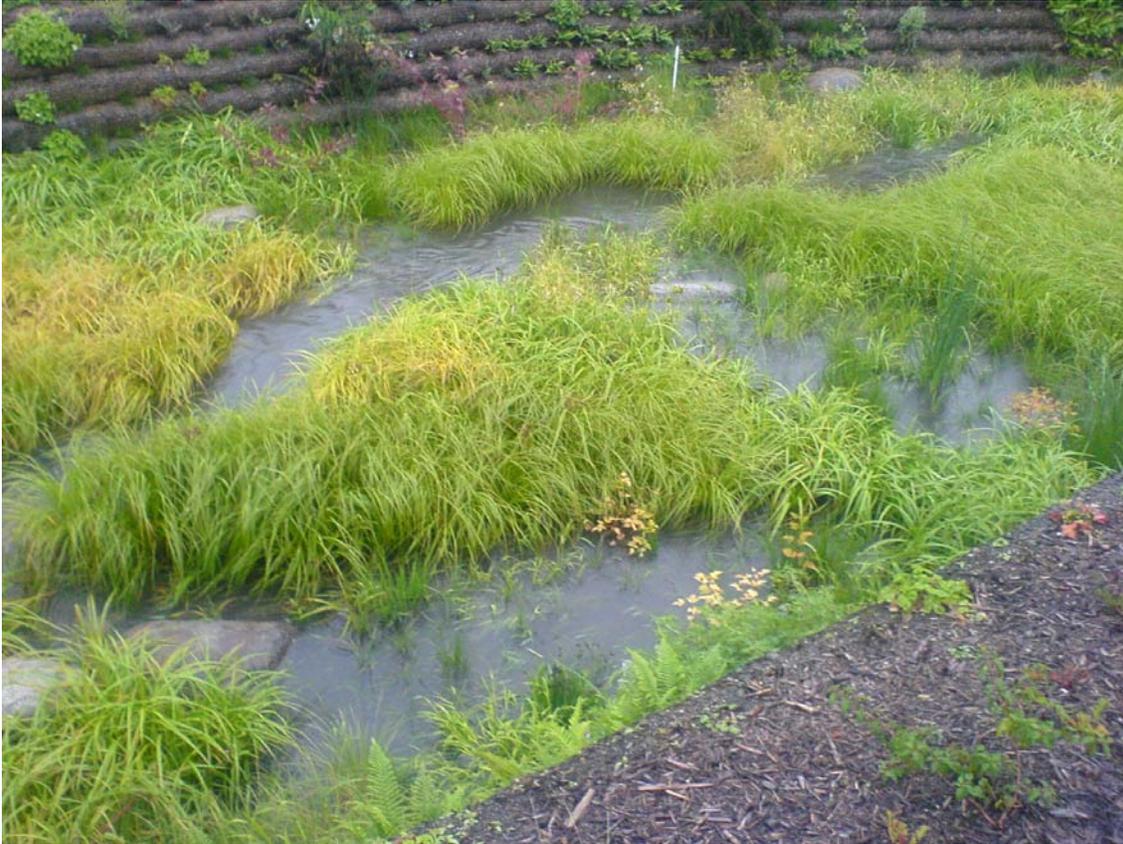
Figure 8 – Plantings in Bioswale

least several inches above the 10-inch flow depth during the winter. This resulted in a list of emergent rushes, sedges, and bulrushes 15 to 36 inches in height (SvR Design Co. 2005). Because the site has a variety of exposures and micro-climates, a wide selection of plants were planted throughout the Water Quality Channel to observe comparative performance. Plants were selected and spaced to provide maximum density between the soil surface and the 10-inch water level (See Figure 8 – Plantings in Bioswale).

Based upon these assumptions, the Washington State Department of Ecology design guidelines for a standard biofiltration swale specify grasses that are 4-6 inches in height with a target water quality treatment flow depth of 2-3 inches. As discussed above, the Facility’s site was not large enough to accommodate a biofiltration swale with these characteristics. The Facility’s available space required a target water treatment depth of 10-inches in order to meet the 5 minute HRT for the 13cfs flow rate target. Working from the goal that the winter vegetation must provide the necessary resistance, the design team looked for plants that could maintain an upright biomass at

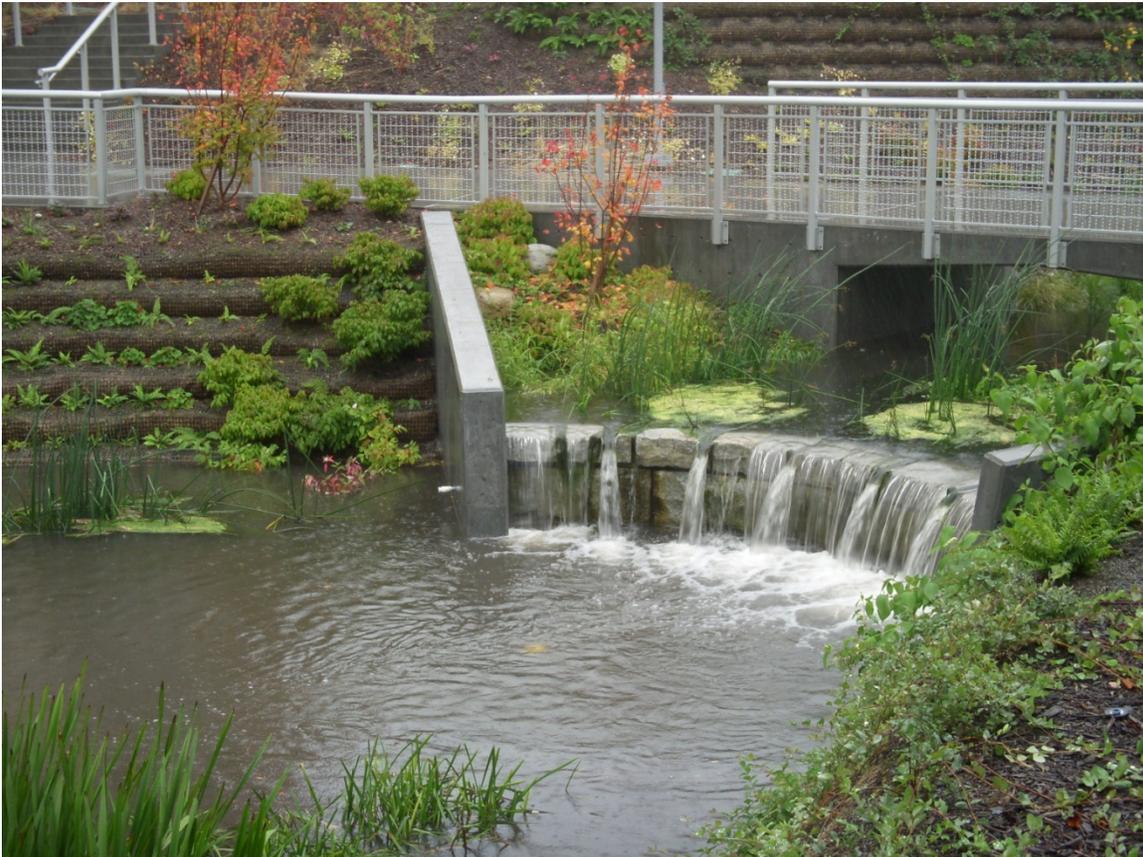
Figure 9 – Waterfall at Inlet to the Water Quality Channel

The Facility's functional requirements included creating a welcoming public open space that would both integrate well with surrounding private commercial and residential development and help weave this new development into the existing neighborhood fabric. The Project's goal of blending natural and urban functions became the aesthetic design's underlying theme. Sinuous curves and drifts of vegetation alternate with linear, hard structures and formal layouts. Water serves as the unifying element, meandering within the Upper Cascade Swale and Water Quality Channel, through the site, under bridges, beside pathways, and past plazas and public art. A series of pools and cascading waterfalls within the Upper Cascade Swale and Water Quality Channel add a natural playfulness to the design (See Figure 9 – Waterfall at inlet to the Water Quality Channel).

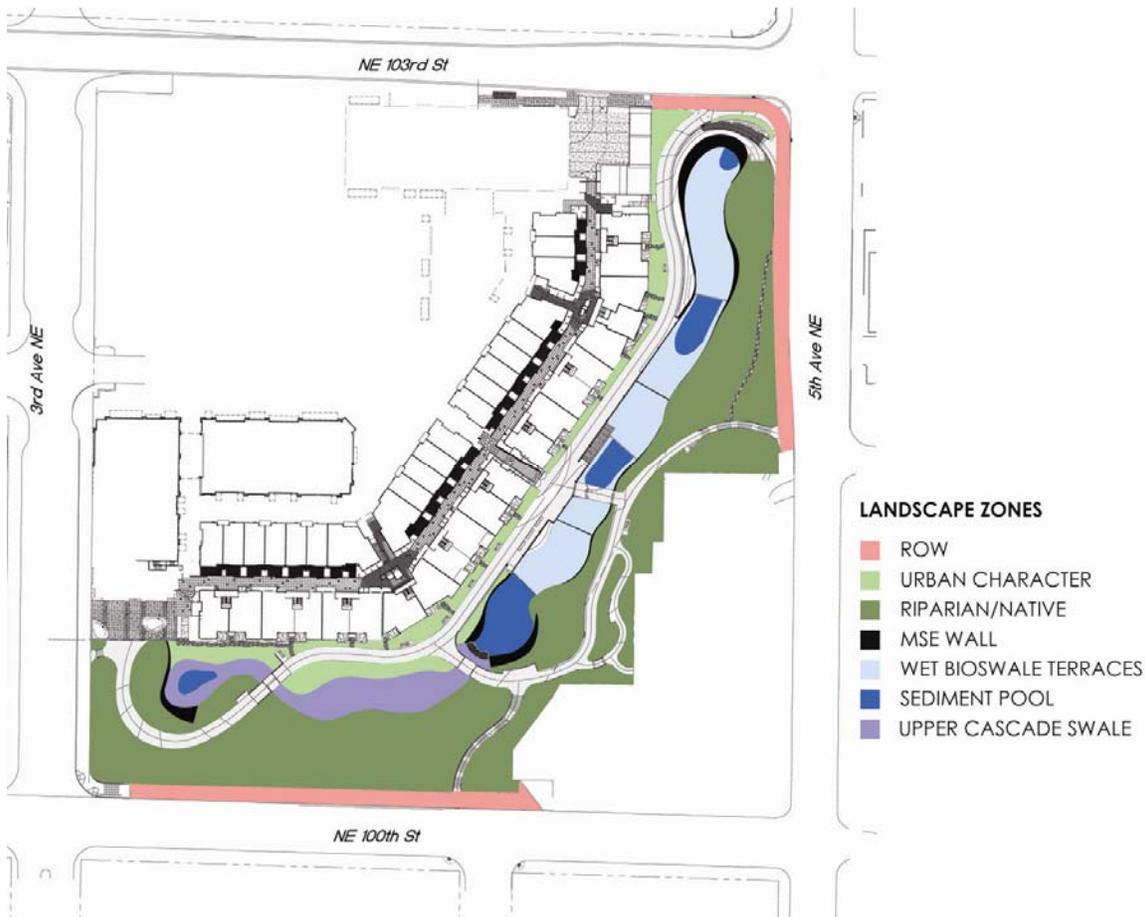
Figure 10 - Landscape Zones

The Facility's planting design is divided into a series of landscape zones (See Figure 10 – Landscape Zones). The Riparian/Native Zone plantings of primarily native species on the east and south slopes provide habitat value and seasonal interest. Along the main pathway, or Urban Character Zone, ornamental and native plants provide additional texture and visual interest. The Upper Cascade Swale plantings offer a wide variety of emergents and facultative species that provide habitat for birds, insects and other wildlife. As noted earlier, plants within the Wet Bioswale Terraces establish a thick carpet of vegetation to slow and treat the incoming stormwater in coordination with a string of planted Sediment Pools. The selection of plant species in all landscape zones is aimed to maximize and enhance wildlife habitat (See Figure 11 – Emergent Plantings Mimic a Streambank).

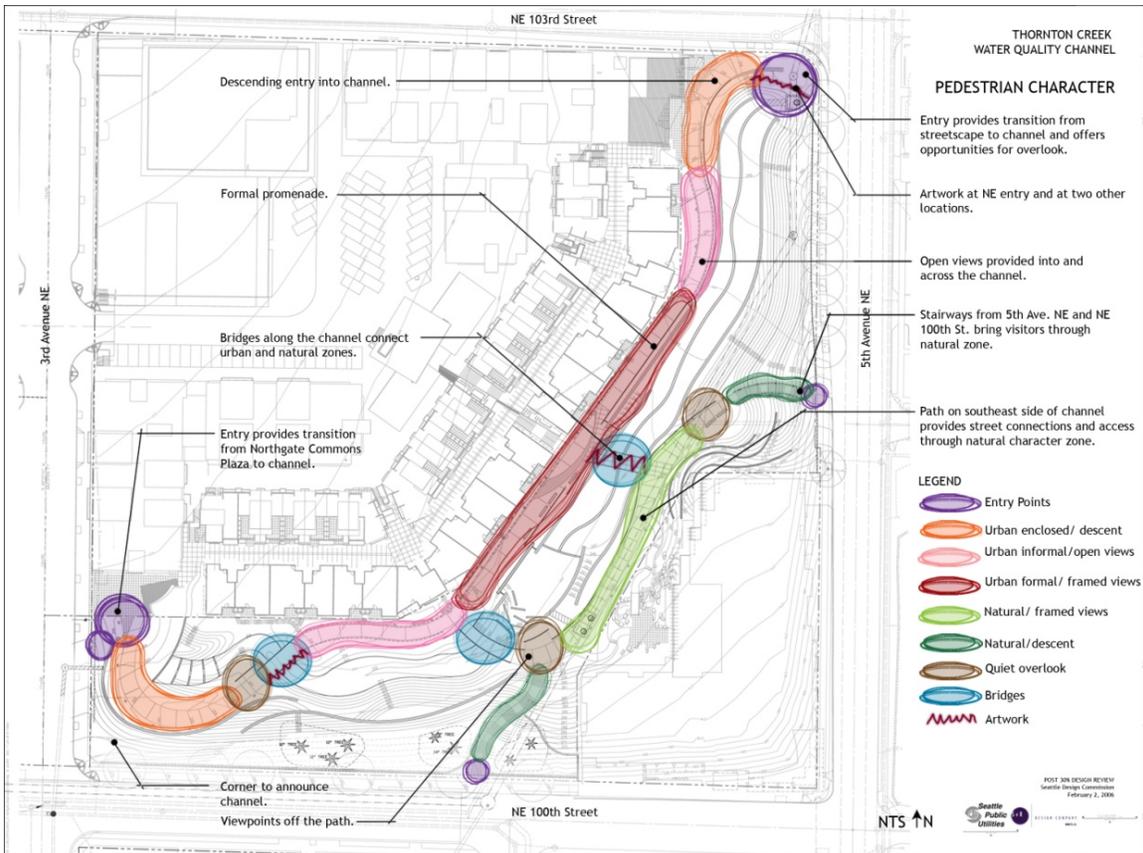
Figure 12 - Pedestrian and Open Space Character Study

The Facility provides for public access and pedestrian circulation (See Figure 12 – Pedestrian and Open Space Character Study). The Upper Cascade Swale and Water Quality Channel run down the center of the Facility. They are flanked on both sides by north-south pedestrian paths that connect the Facility to the surrounding neighborhood. The promenade along the Facility’s north bank is the more direct, formal route. The path on this side is wider to accommodate maintenance vehicles and pedestrians travelling between the Transit Center west of the Facility, Northgate Commons Plaza, and the neighborhoods and commercial areas to the north of the Facility. This promenade also serves as the entrance path to the market rate condominiums and townhouses. The stairs and the shorter, more curving path along the south side of the Facility take the pedestrian through the more informal, naturalistic zone adjacent to the Senior Center. This route is the most direct route between the residential neighborhoods to the east and the office complex to the south. Pedestrian bridges across the Upper Cascade Swale and the Water Quality Channel connect the Facility’s main paths. ADA access to the Facility is provided at the southwest entrance through the Thornton Place development. Once within the Facility, all paths and bridges along the Upper Cascade Swale and Water Quality Channel are fully ADA accessible.

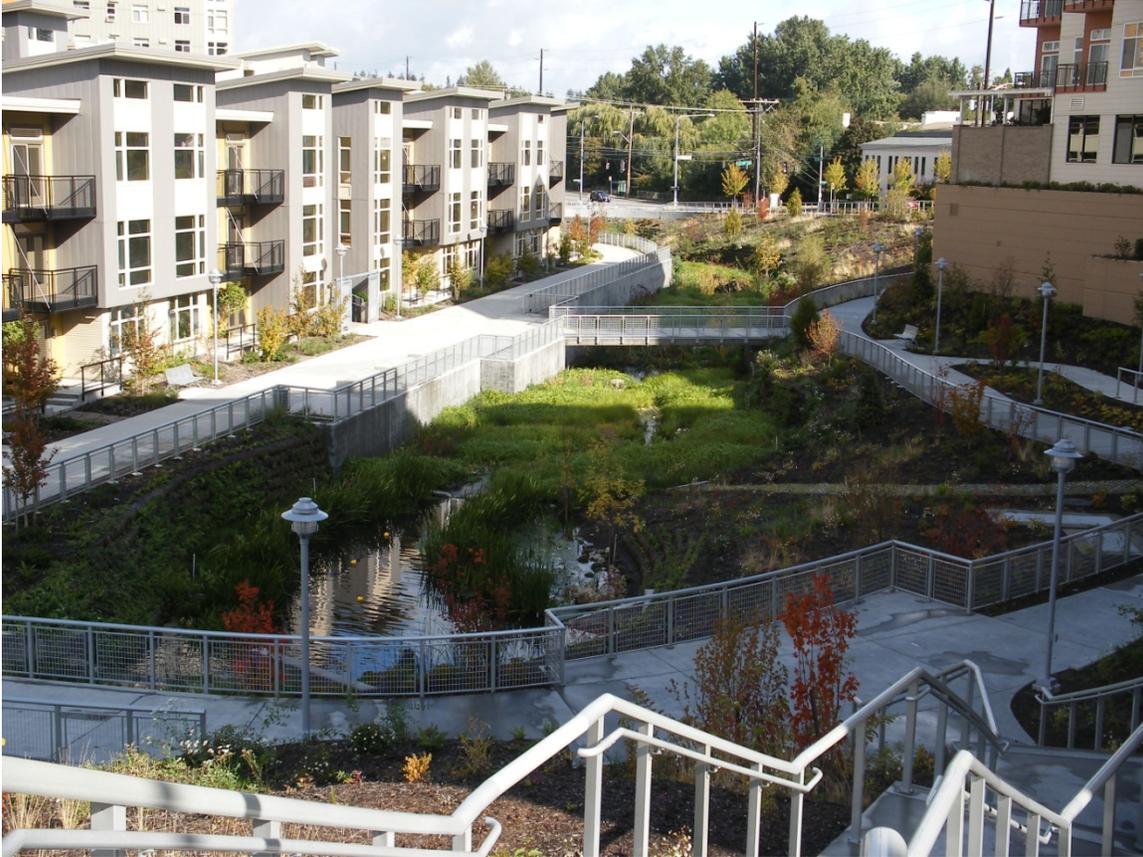
Figure 13 – Pedestrian Paths and Bridges

In order for SPU’s operation and maintenance team to have easy access to the Facility, staging zones and truck drive-in/back-out areas were required. Because these areas need to be continuously dedicated to maintenance functions, the required open hardscape areas are designed to also serve as pedestrian plazas. Three primary plazas and three smaller nodes are located where the paths intersect. In addition to providing the required space for maintenance vehicles, these plazas, pathways, and nodes draw pedestrians towards the water. They also lead to new retail stores and the Transit Center. The design gives people the chance to view the moving water from a variety of dramatic vantage points, as well as from quieter, more contemplative overlooks (See Figure 13 – Pedestrian Paths and Bridges).

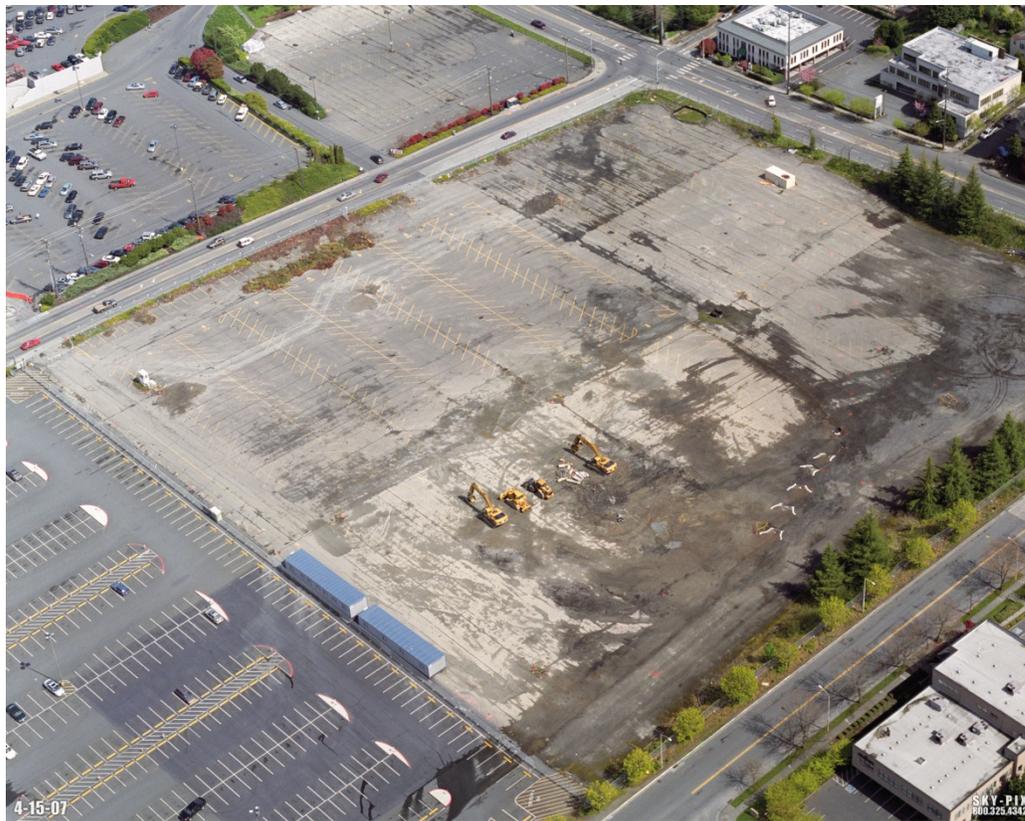
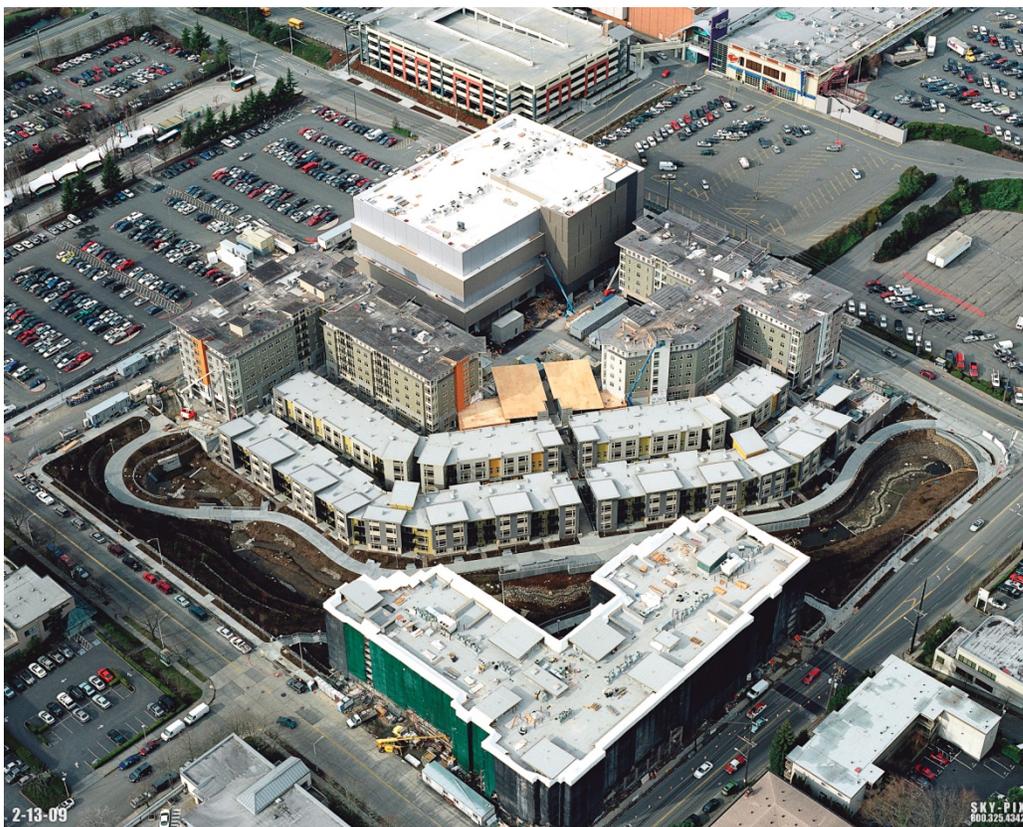
The Facility design that resulted from this private/public partnership demonstrates how even physically constrained sites can provide an opportunity to serve multiple purposes while improving environmental function. The modified biofiltration swale design enables a more efficient use of the available space and provides a unique 2.7 acre public open space amenity in the heart of this dense urban neighborhood. What was once a sterile, paved parking lot is now a unique urban park, complete with trails, bridges, plazas, and art (See Figure 14 – Before and During Construction and Figure 15 – The Completed Facility).

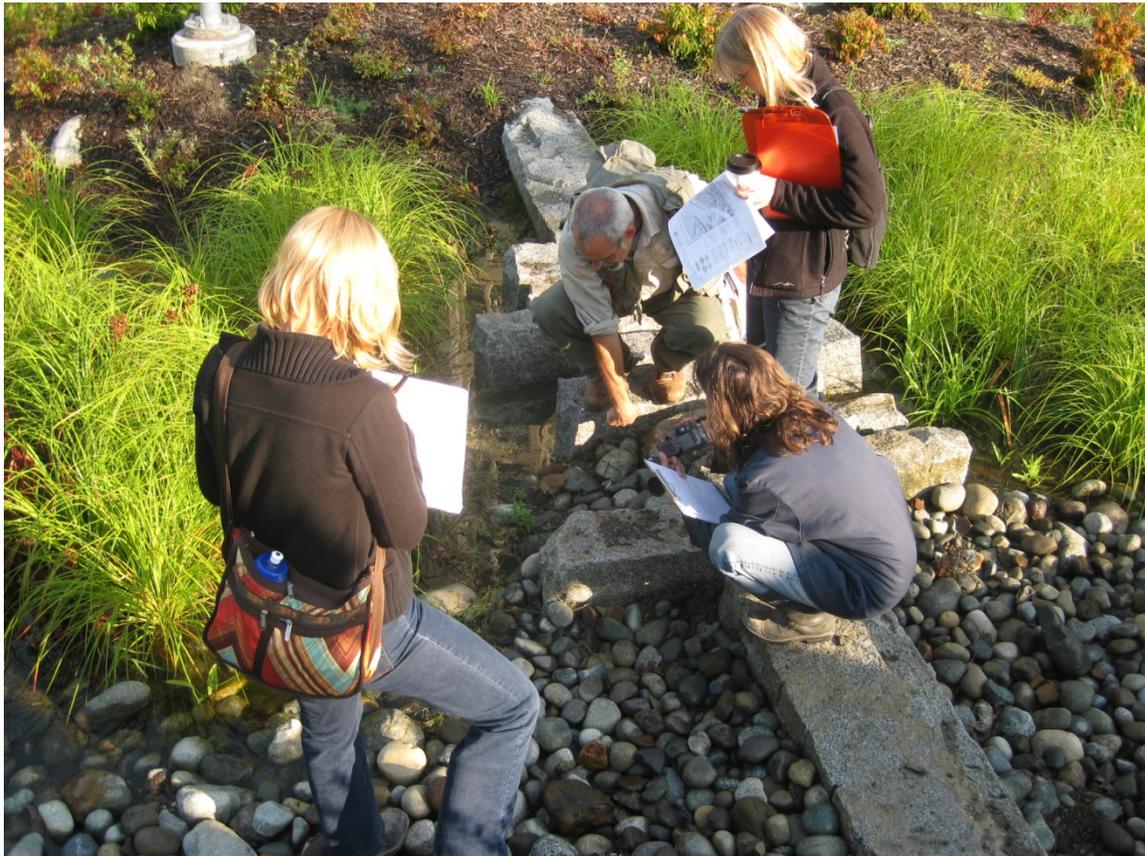
Figure 16 – Inspecting Plants in the Upper Cascade Swale

Vegetation monitoring will be conducted in the Upper Cascade Swale and the Water Quality Channel to evaluate which plant species are succeeding. This information will be used to adaptively manage vegetation in the Upper Cascade Swale and the Water Quality Channel and to inform future biofiltration swale design (See Figure 16 – Inspecting Plants in the Upper Cascade Swale).

Randomly selected plots within the vegetation zones will be monitored in the spring and late summer starting in the late summer of 2009. Within each plot, percent cover of each species will be determined and the health of each plant noted. In addition, permanent photo points will be established at vantage points above the Upper Cascade Swale and Water Quality Channel to document the vegetation's overall condition. Photos will be taken during each site visit for the vegetation monitoring.

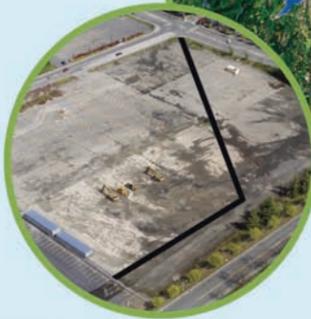
This is what Thornton Place looked like before the Channel - a paved lot with a pipe underground.

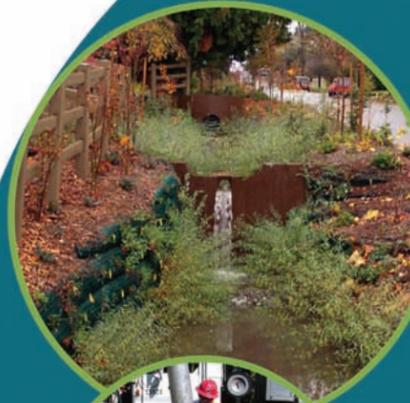
The sediment ponds slow down the flow of the stormwater and allow particles and pollutants to settle out. The water leaves the ponds through a small dam or weir. Weirs are located at the outlet of the sediment ponds and throughout the Channel to spread the flowing water across the wide Channel bottom. Although stormwater from 660 acres (500 football fields) joins the Channel here, runoff from some large storms will bypass in a pipe, protecting the Water Quality Channel from erosion.

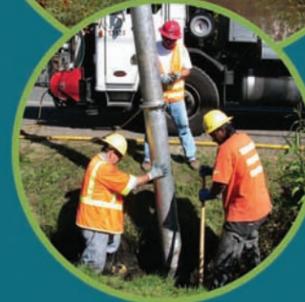
In this pond, sediment, dirt and pollutants will settle to the bottom where they'll accumulate over time. The accumulated sediment will be removed by Seattle Public Utilities crews; leaving cleaner and clearer water when it reaches Thornton Creek at the end of the Channel.

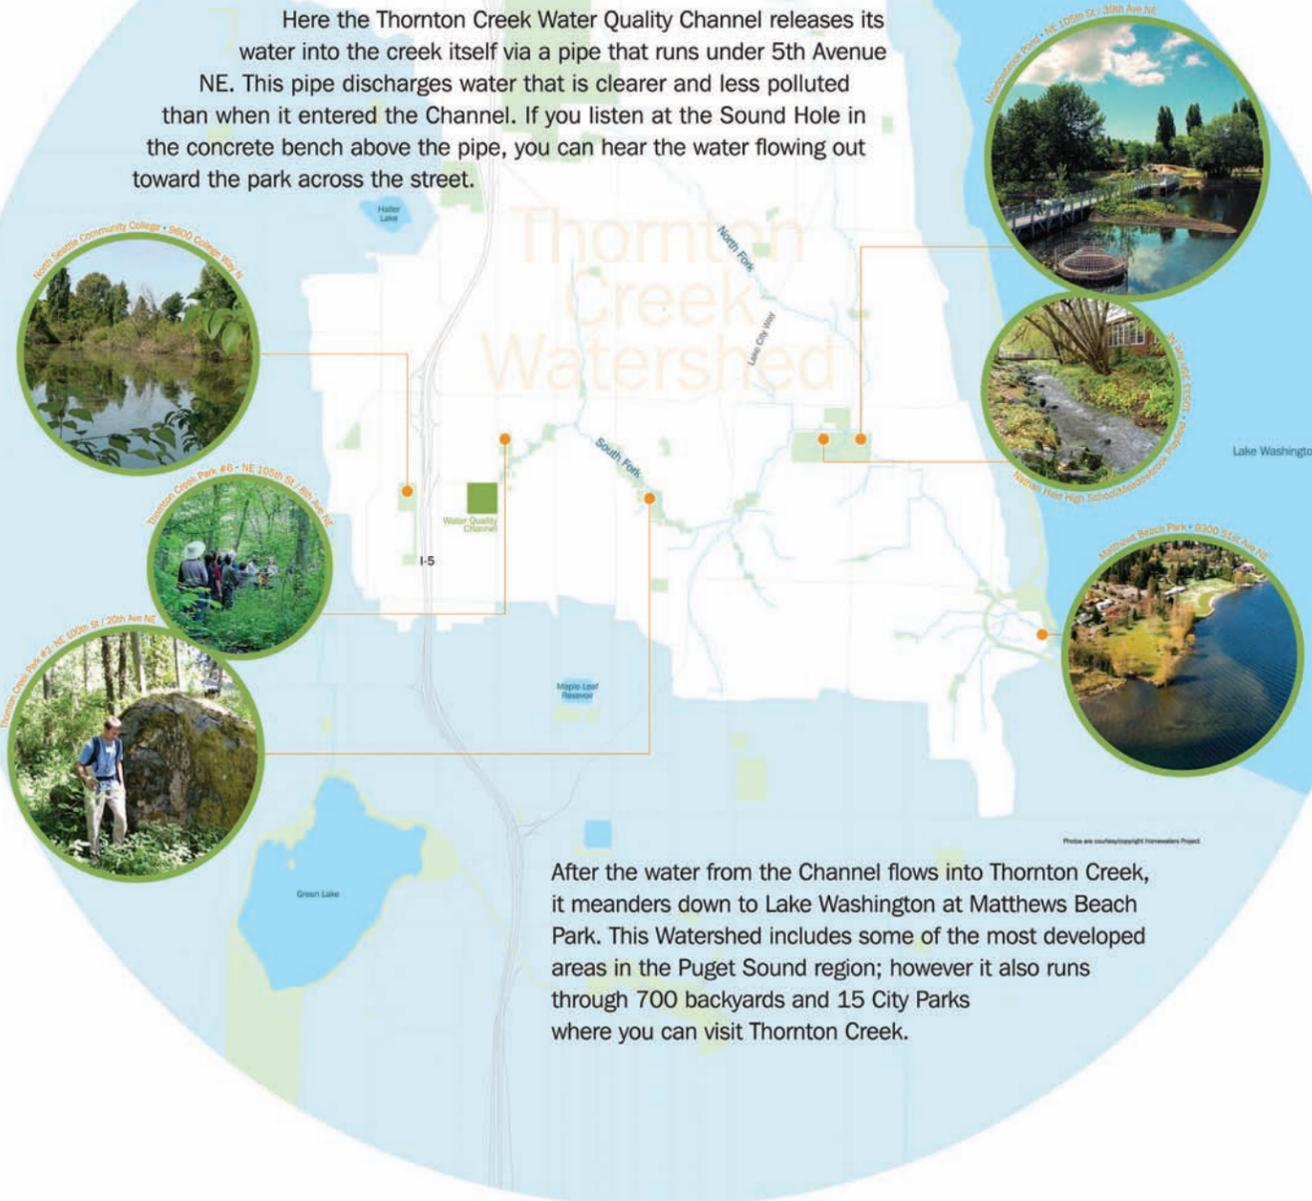
Here the Thornton Creek Water Quality Channel releases its water into the creek itself via a pipe that runs under 5th Avenue NE. This pipe discharges water that is clearer and less polluted than when it entered the Channel. If you listen at the Sound Hole in the concrete bench above the pipe, you can hear the water flowing out toward the park across the street.
